CASE HISTORY - BASED ANALYSIS OF LIQUEFACTION IN SLOPING  
GROUND

DISSERTATION

Submitted in partial fulfillment of the requirements  
for the degree of Doctor of Philosophy in Civil Engineering  
in the Graduate College of the  
University of Illinois at Urbana-Champaign, 2012

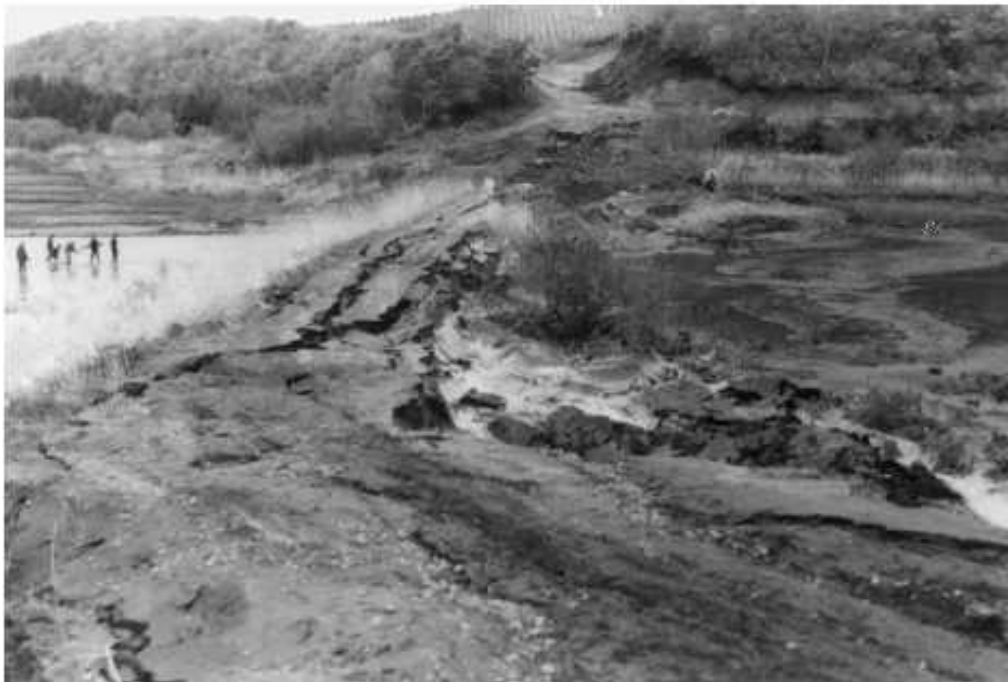
Figure 7.5 Damage to Yamanaka dam caused by the 1968 Tokachi-Oki earthquake (from Tani and Nakashima 1999)

The dam suffered severe slumping and flow of the reservoir-side slope during the 1968 Tokachi-Oki earthquake, as illustrated in Figure 7.5. Following the earthquake, the upstream slope and crest were regraded to their pre-earthquake conditions. The upstream slope of Yamanaka dam again failed during the 1978 Miyagi-ken-Oki earthquake, although the failure was not as severe as in 1968. Following this earthquake, the dam slope was regraded, and a sheetpile wall was driven through the slope to mitigate displacements during future earthquakes. Interestingly, during the 1983 Nihon-kai-Chubu earthquake, a part of upstream slope suffered cracking and minor slumping (despite the mitigation effort) and crest settled about 80 cm, as illustrated in Figure 7.6. Following the earthquake, the sheetpile wall was repaired and the slope was regraded. Nevertheless, the upstream slope again suffered cracking and minor slumping during the 1994 Sanriku Haruka-Oki earthquake, as shown in Figure 7.7. Following the earthquake, the upstream slope was again regraded.

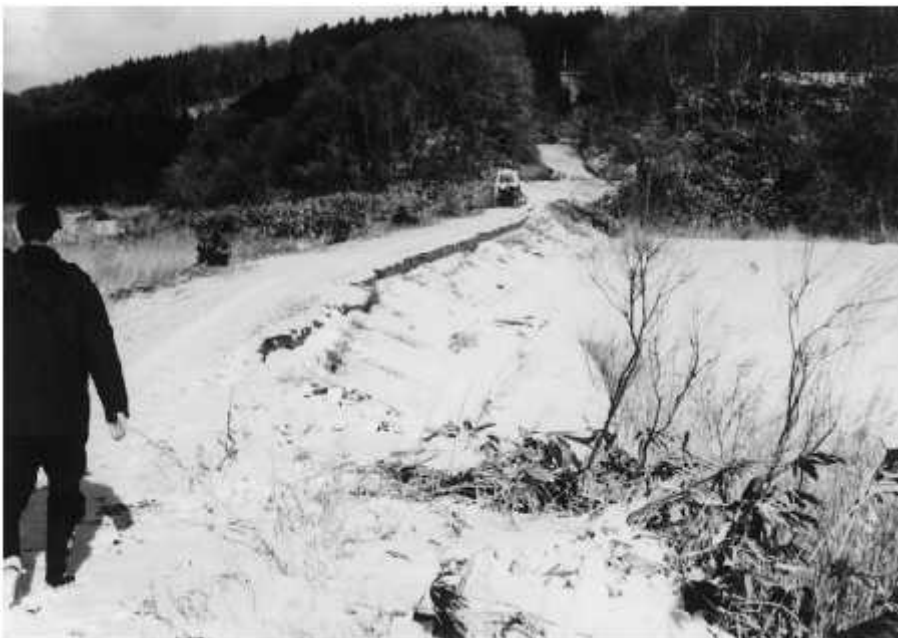
**Figure 7.7 Damage to Yamanaka dam caused by the 1994 Sanriku Haruka-Oki earthquake (from Tani and Nakashima 1999)**

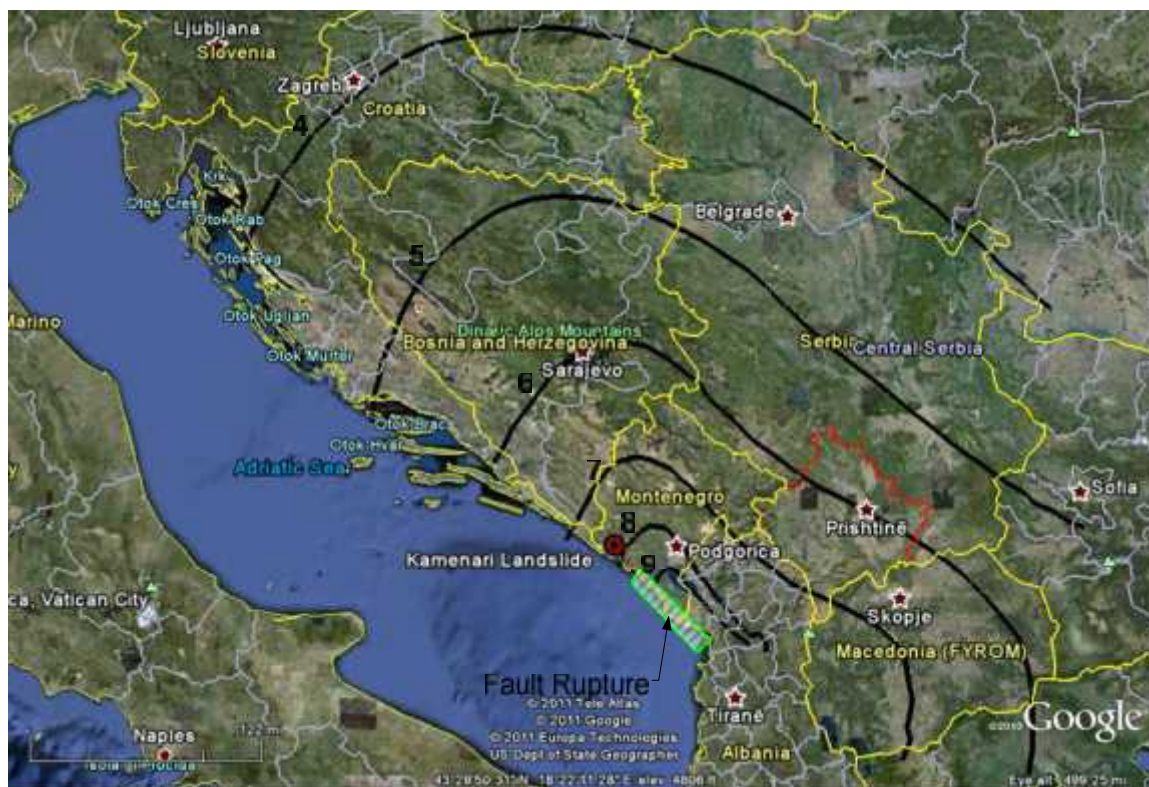
Figure A.8 Map of Adriatic Sea, fault rupture from 1979 Montenegro earthquake, and isoseismic map of the intensity of shaking (reproduced from Ishihara 2005; background image courtesy of Google Earth ©2011)

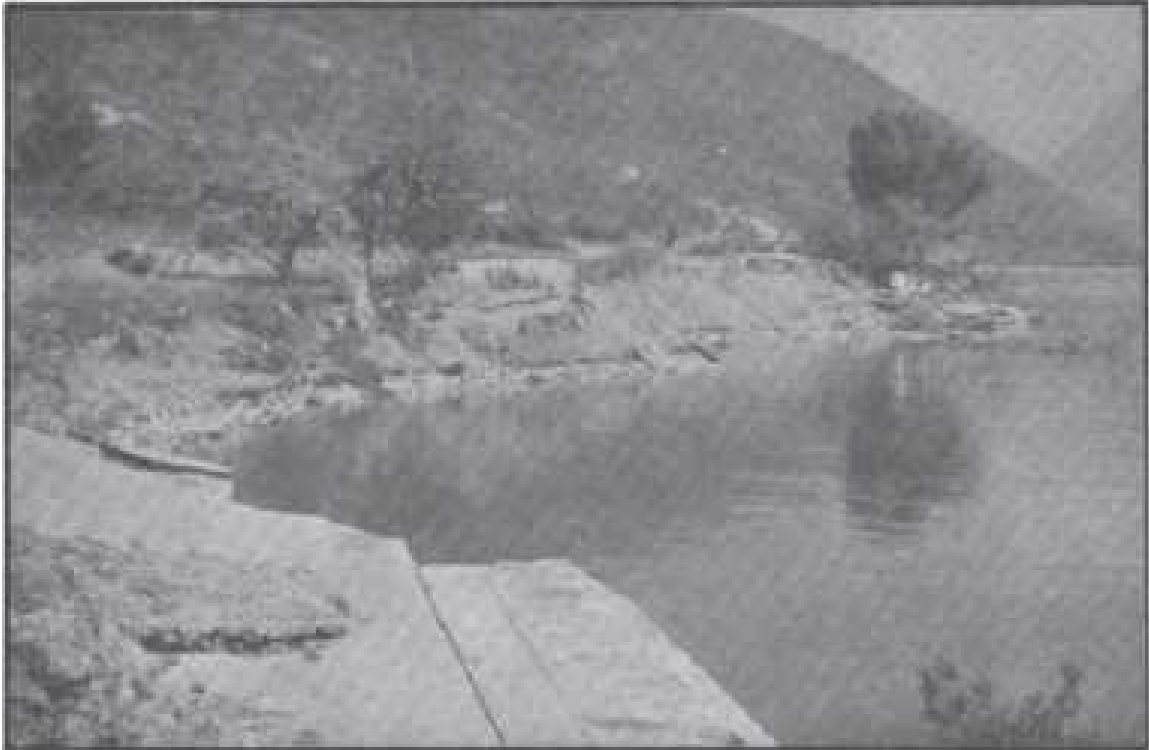
**Figure A.11 Landslide and road failure at Kamenari (from Anicic et al. 1980)**

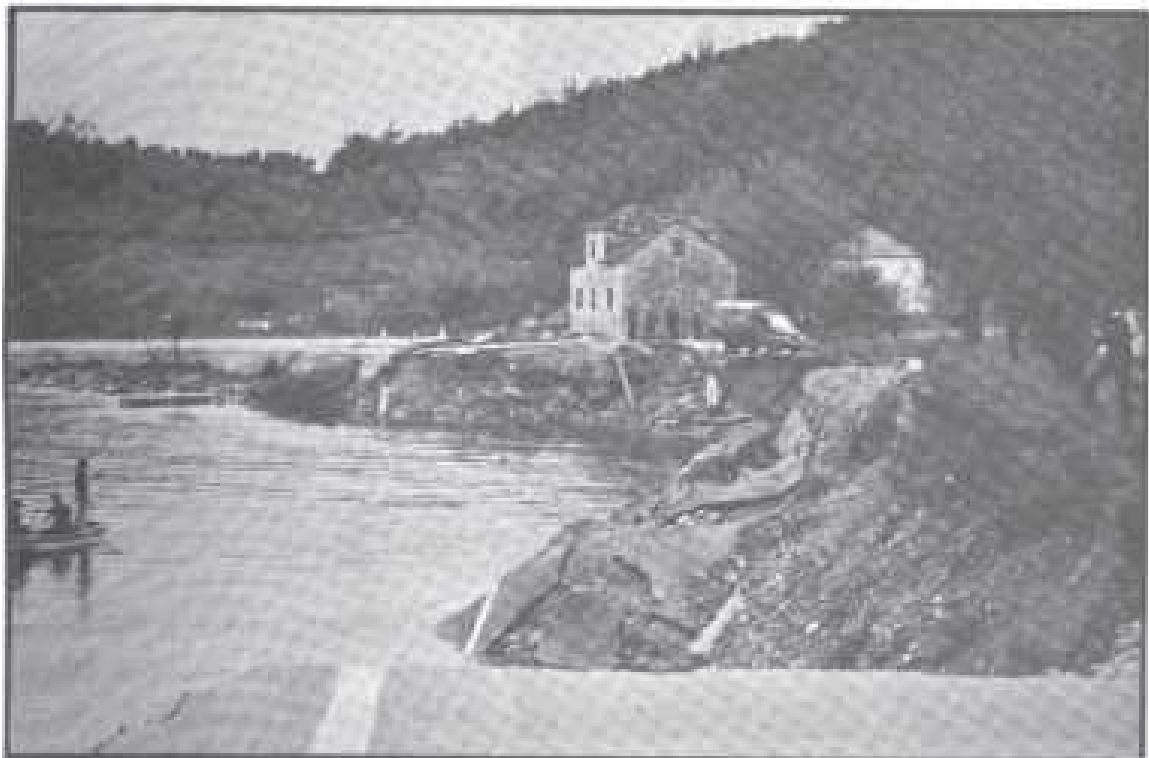
**Figure A.12 Landslide and coastal road failure at Kamenari (from Anicic et al. 1980)**

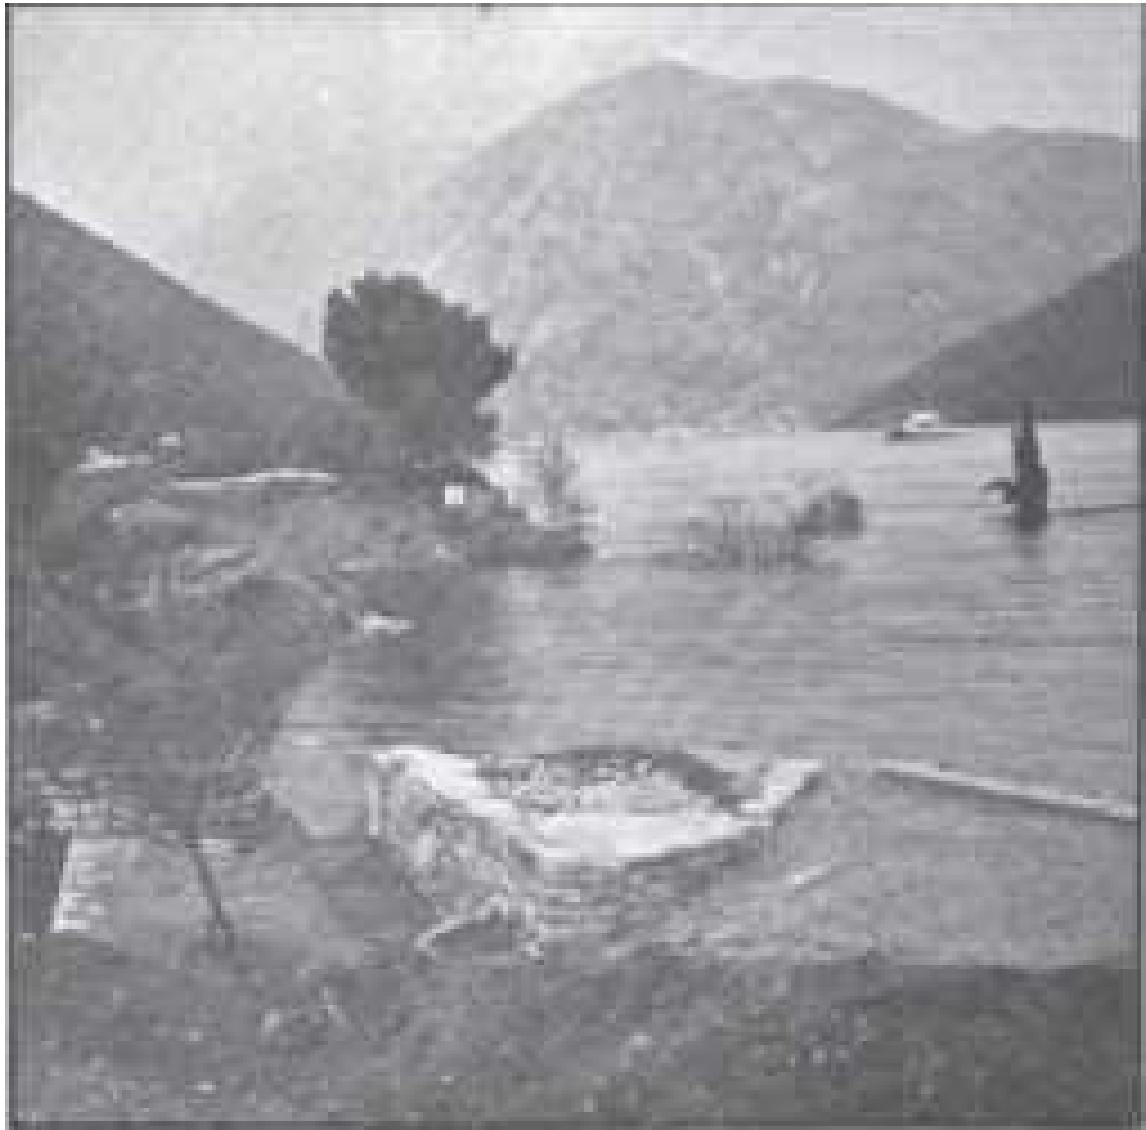
**Figure A.13 Coastal road failure at Kamenari (from Anicic et al. 1980)**

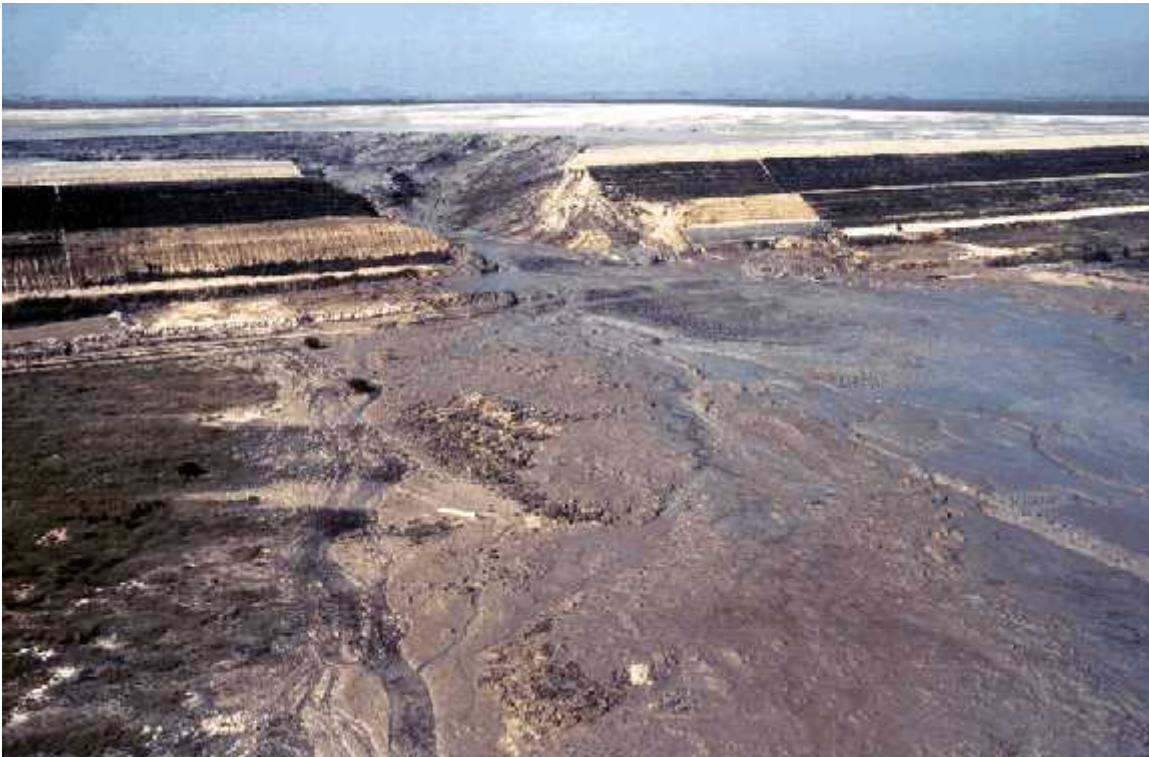
**Figure A.78 Aerial photographs of Merriespruit Dam failure (from [www.tailings.info](http://www.tailings.info); reproduced with permission from Jon Engels)**

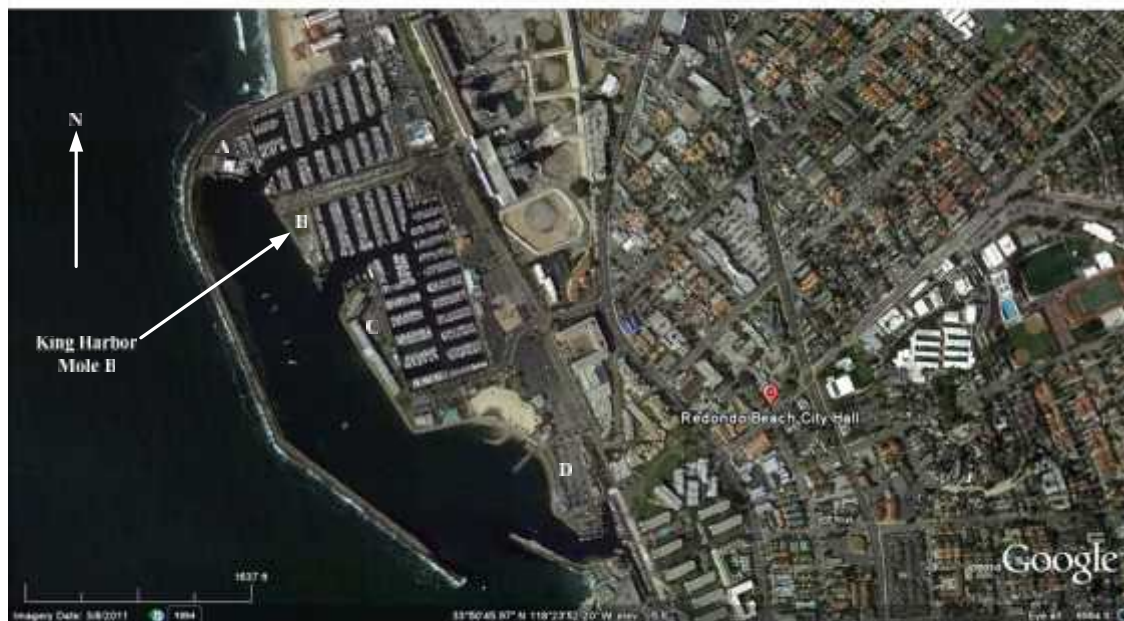
Figure A.86 Estimation of ground slope from elevation profile defined by Google Earth Inc. © 2011 by overlapping the plan view given by Niekerk and Viljoen (2005) on the background Google Earth image.

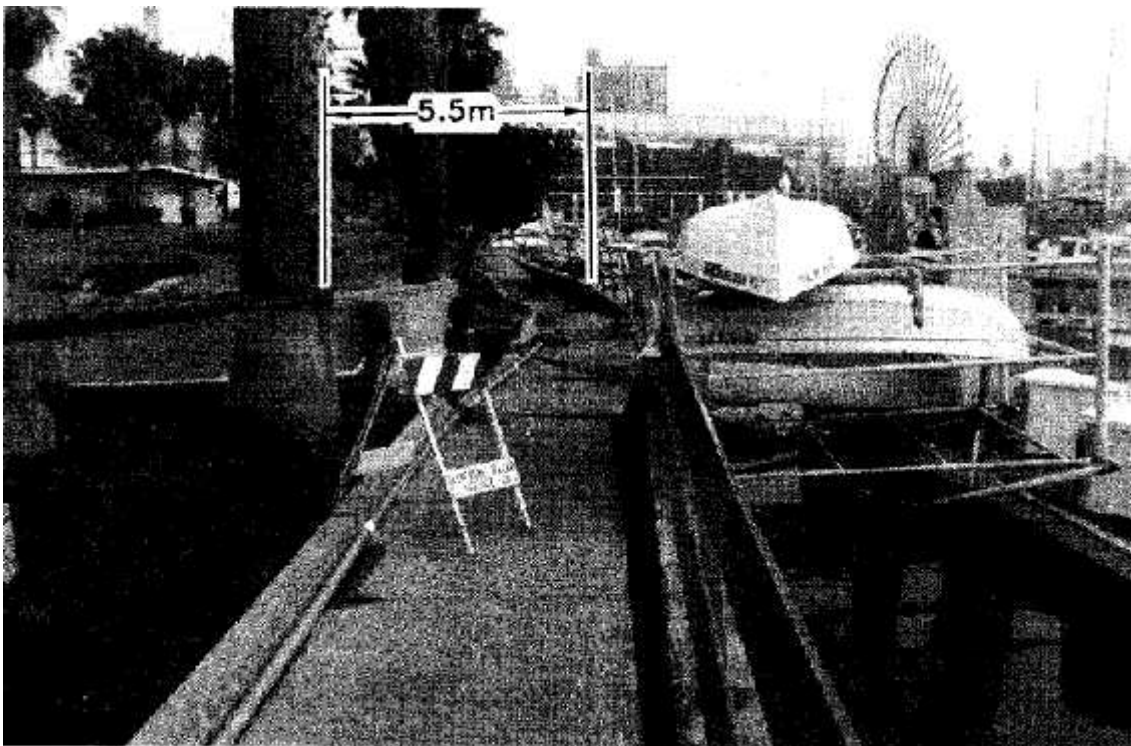
Figure A.92 Looking west along southern graben or fissure zone on the morning of the earthquake (from Kerwin and Stone 1997)
